# **AN INVESTIGATION OF EMULSION STABILIZED LIMESTONE SCREENINGS**

**FINAL REPORT  
IOWA HIGHWAY RESEARCH BOARD  
PROJECT HR-309**

**FEBRUARY 1994**

**Iowa Department  
of Transportation**

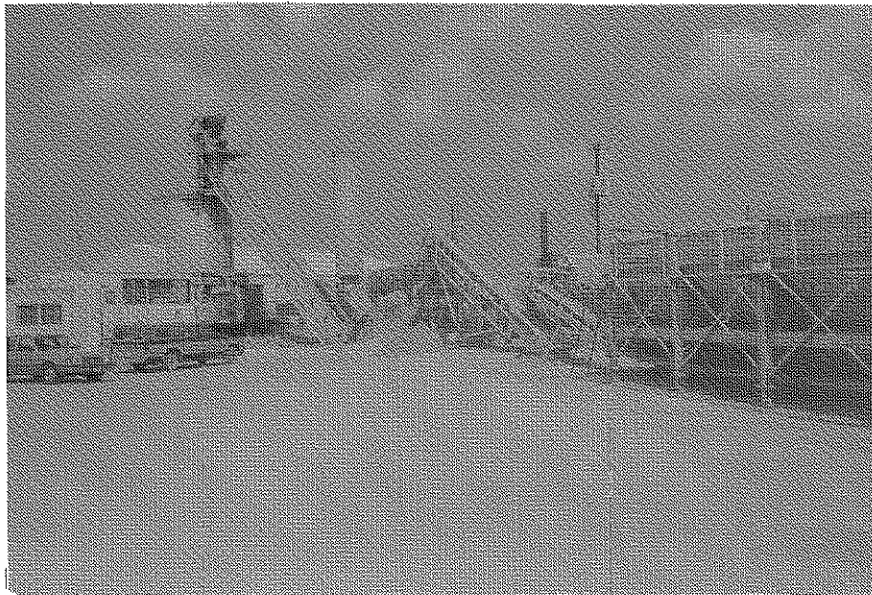
Photo 1: Contractor's drum mixer plant

Vulcan Industries produced the mix used on the project. The same limestone screenings were fed from two bins which were metered to feed aggregate to a continuous drum mixer. Emulsion was sprayed into the drum at the rate needed to obtain the desired residual asphalt content in the mix (2.5%, 3.5%, or 4.5%). The mix production rate was low, usually running around 100 tons (907 Mg) per hour.

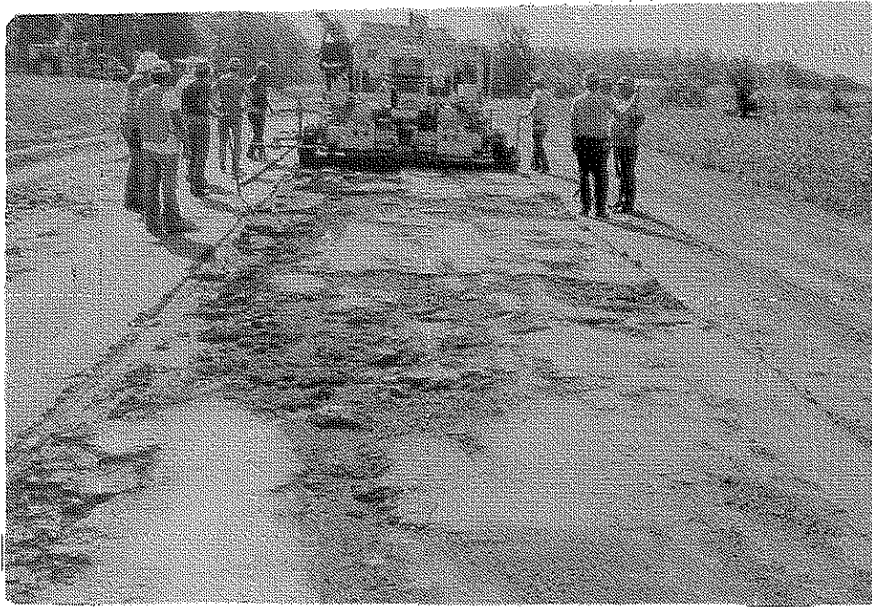
Photo 3: Torn base mat placed using asphalt paver

After laying the westbound lane of Section 1, the contractor added a second lift on the eastbound lane of Section 1. This was required because the asphalt paver used initially did not place a full 6 in. (150 mm) of base. Once the second lift was completed, the contractor continued paving the westbound lane of Sections 2 and 3, which were completed without further incident.

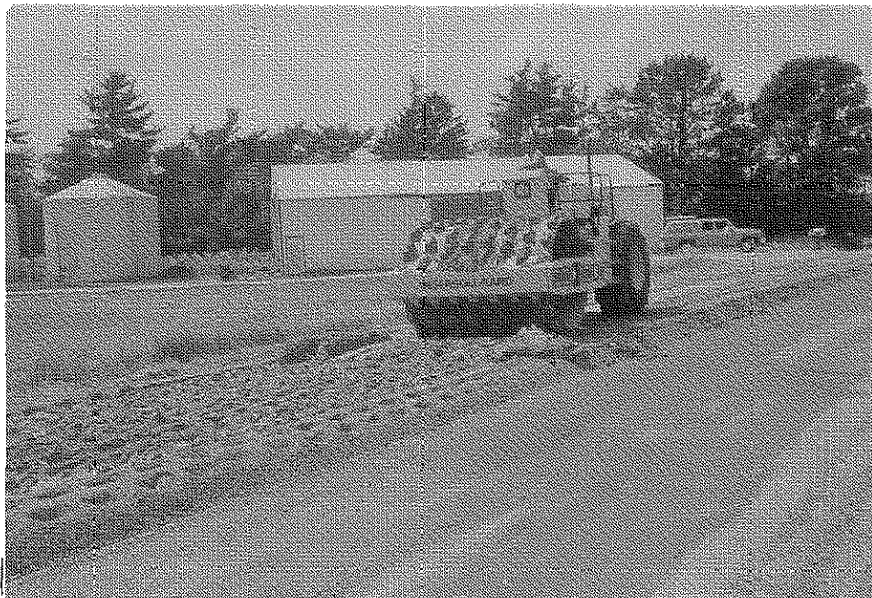
Photo 4: Padsfoot roller compacting base laid with spreader box

In order to increase the aeration rate, eliminate shear cracking, and improve depth of compaction, a padsfoot vibratory drum was used to compact and aerate the laid base. The aeration increased the curing rate of the mix and allowed full depth compaction to be completed much sooner than with the smooth drum roller. A motor grader was used to level the surface once the padsfoot had made several passes over the base. Final compaction was done with a pneumatic tired roller providing a smooth, tight surface.

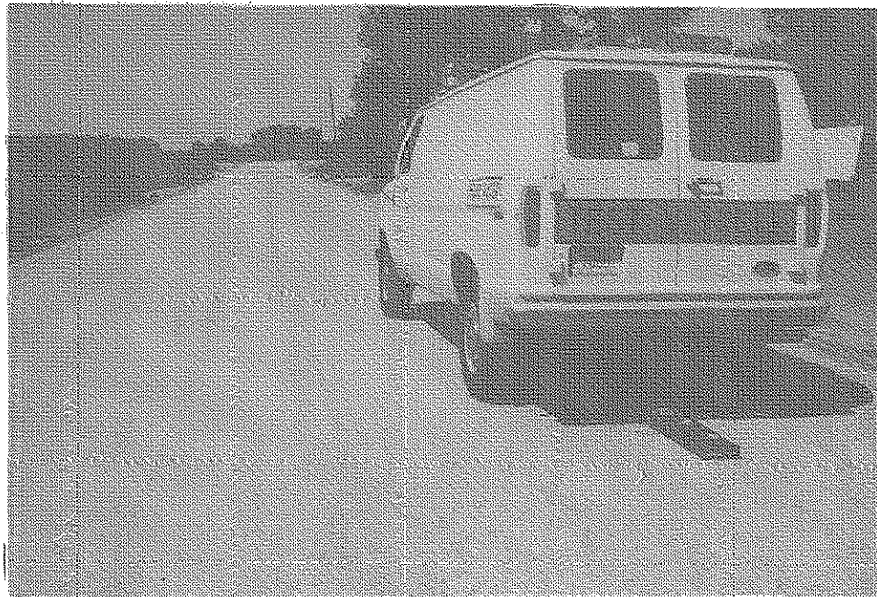
Photo 6: DOT Road Rater testing being conducted on finished roadway

Road Rater testing has been conducted annually on the entire project (Table 2 and Table 3). The Road Rater is a dynamic deflection measuring device used to determine the structural adequacy of pavements. The differences in pavement structural ratings from year to year may be explained by the fact that annual testing is performed on the outside wheel track during the months of April and May when the roadway exhibits the poorest structural support. The structural rating can vary from one year to the next depending upon the moisture content of the soil at the time of testing.
